Newhailes House Estate, Flower Garden Wall recording.

March 2007

Carried out on behalf of the National Trust for Scotland

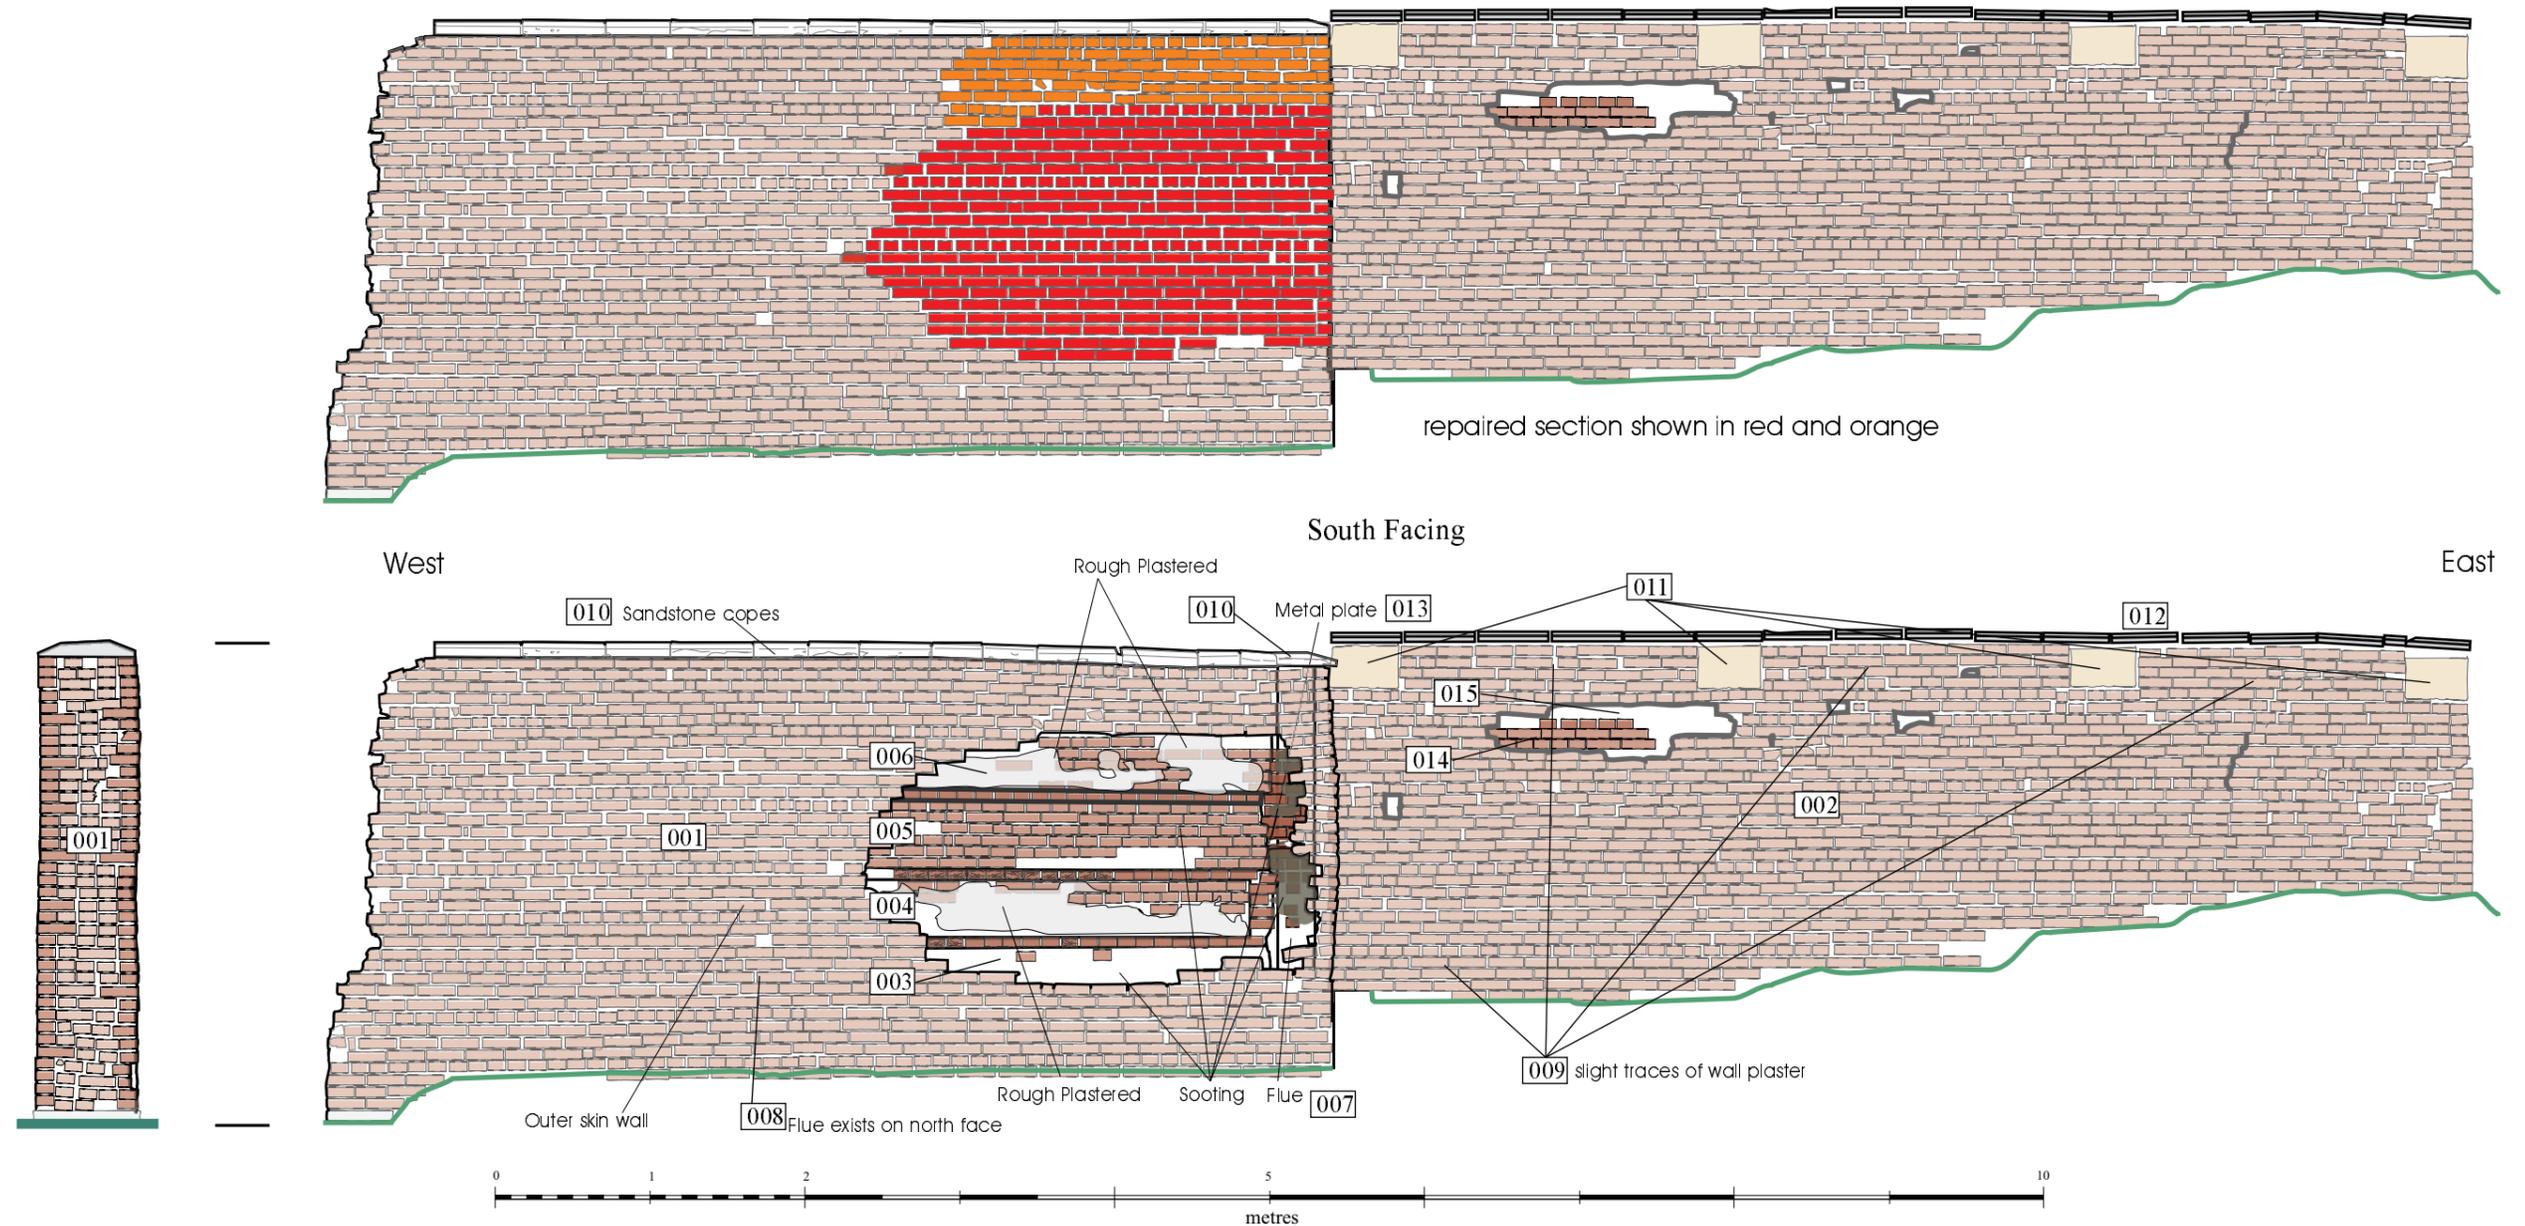
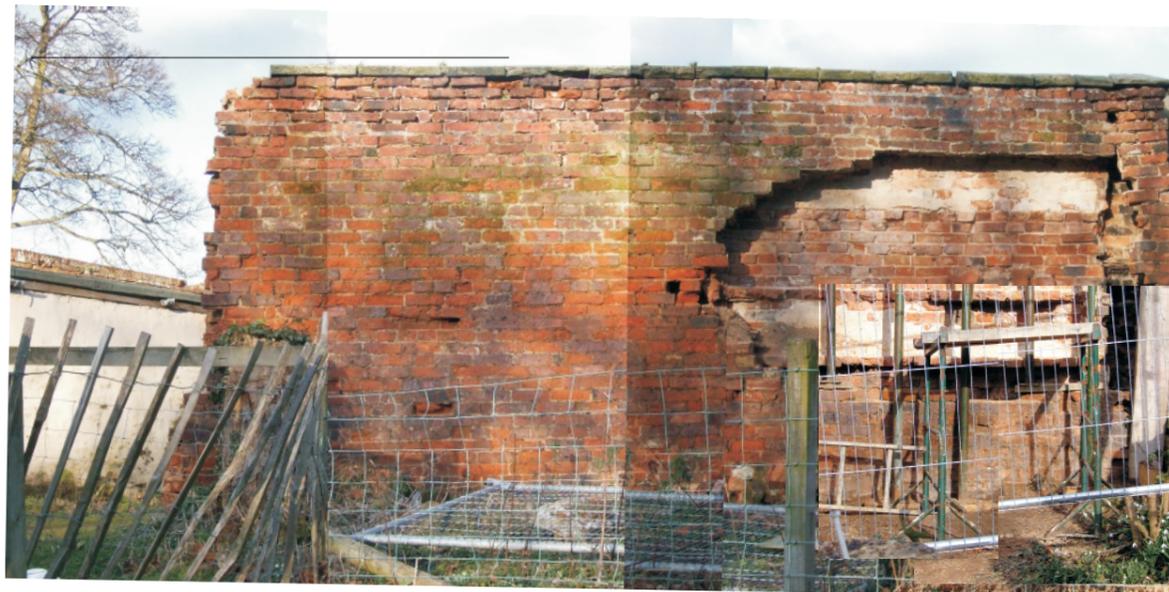
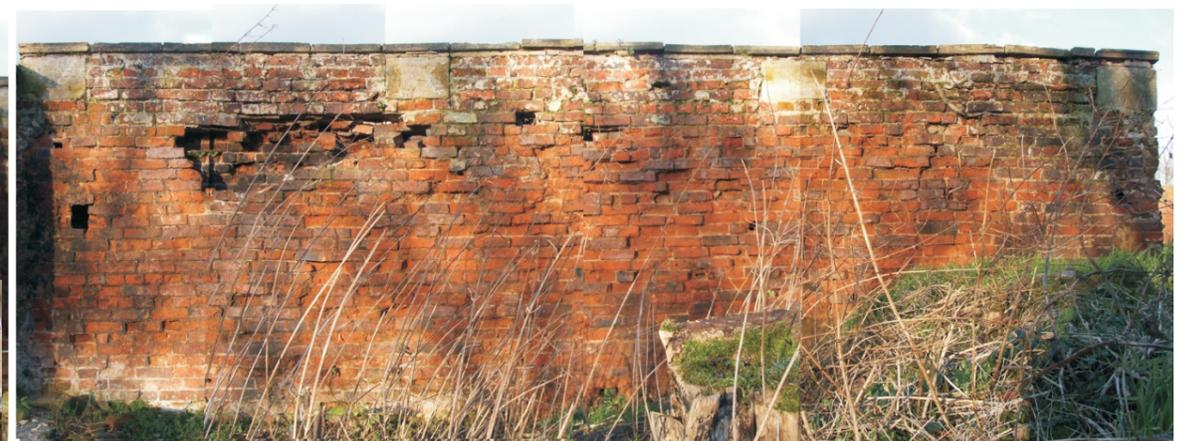
A metal plate [013] has been inserted into the wall from the north side (Fig. 5), and this could have been slid into or out of the vertical flue to control draught which was integral to the original system.

Figure 3: Top: Wall showing area to be repaired and position of bricks
 Middle: Wall recorded as seen
 Bottom: Photomontage of wall.

This programme of works has recorded the walls as specified. An elevation of repair has been produced (Fig. 5) and the construction and operation of the flue has been interpreted (Fig. 6).

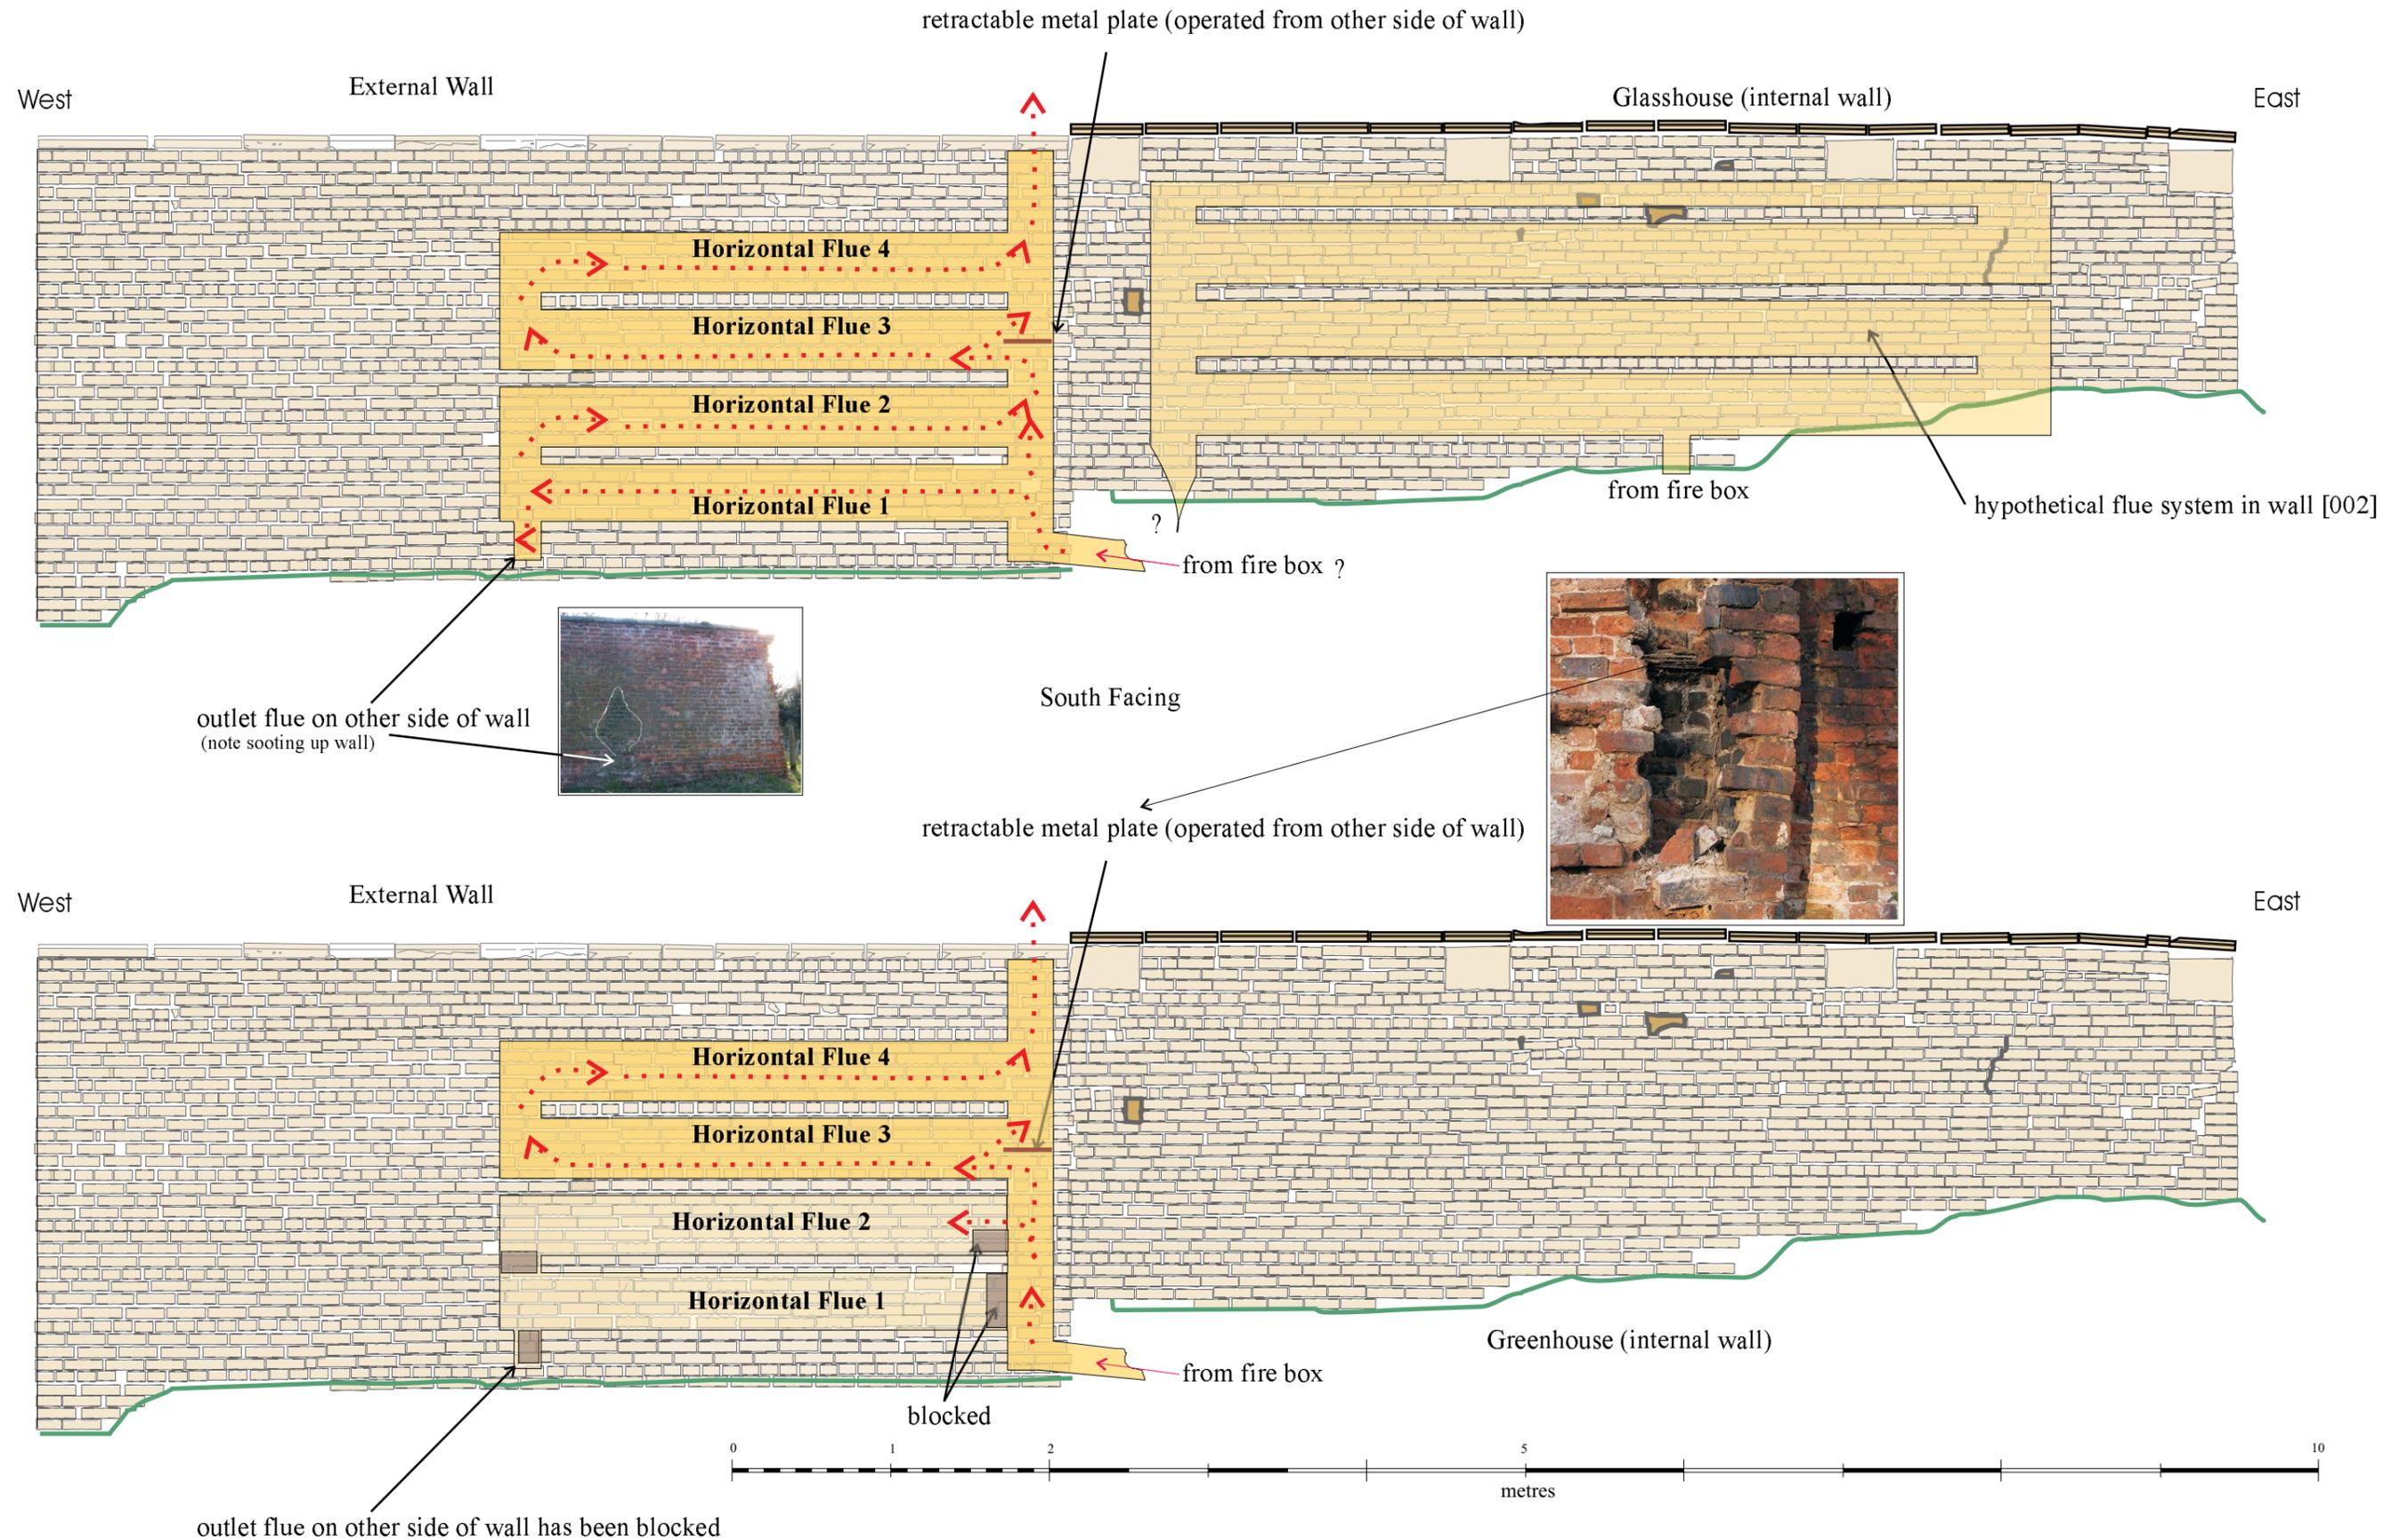
It is clear that two phases of use had taken place within wall [001]. As much as can be understood, the original phase had four horizontal flues [003-6] that drew heat from the main firebox to the rear of wall [002]. The heat would be drawn up both the vertical chimney flue [007] and along flue 1 [003] (the draw for flue 1 is created by a small aperture [008] in the north face of wall [001][not clear what this means]). This would draw hot air into flue 1 [003] and then up into flue 2 [004]. If the iron plate [013] was also set in place (as it is positioned half way down flue 3) the draw would continue along flue 3 [005] and return by flue 4 [006] back to the vertical chimney flue [007]

It is clear that the metal plate was essential for regulating and controlling the system. The deep blackened sooting on the lowest flue [003], and the blocking of this flue at the east and west ends, leads to the conclusion that a fire damaged the system. It is not clear how these systems could have been cleaned to help prevent chimney fires - a more difficult task with complicated horizontal flues that double back on themselves.

The blocking of flue 1 [003] and the partial blocking of flue 2 [004] would have meant that only the top two flues [005 and 6] would continue to work. This would make the use of the metal flue plate essential to ensure that a draw was created through the upper flues rather than directly up the vertical flue and chimney.

Figure 6: Top: Wall as built, with 4 flues operational. Bottom: Wall after blocking of lower flue.

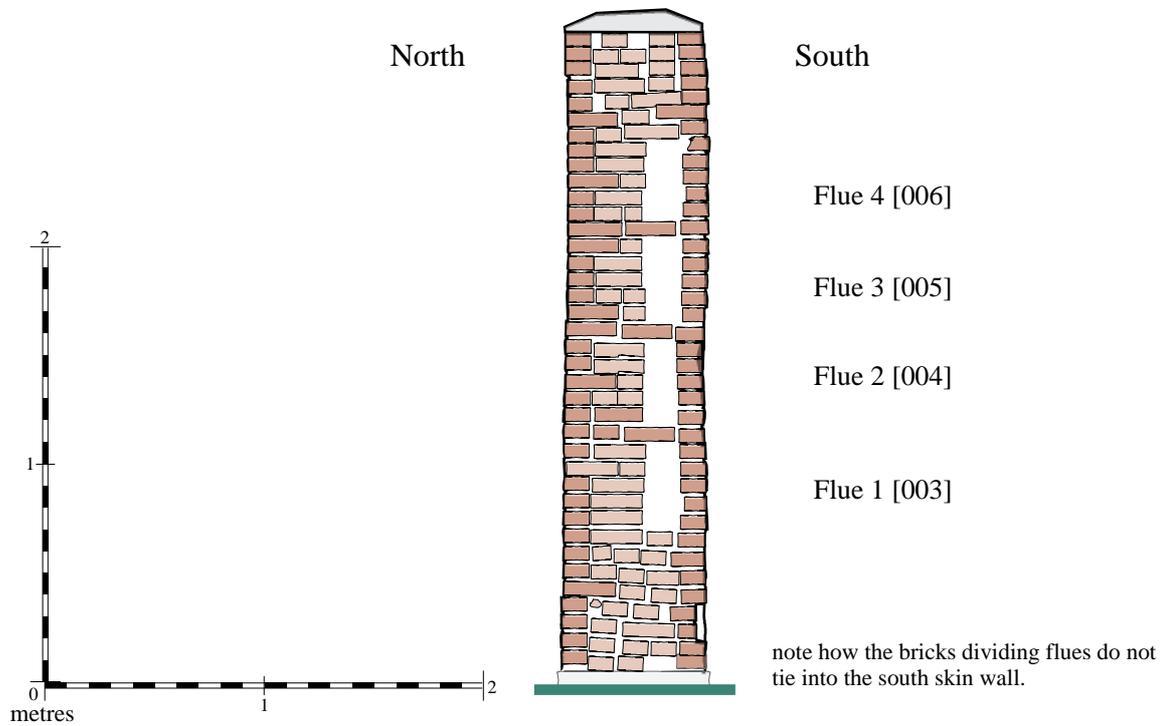
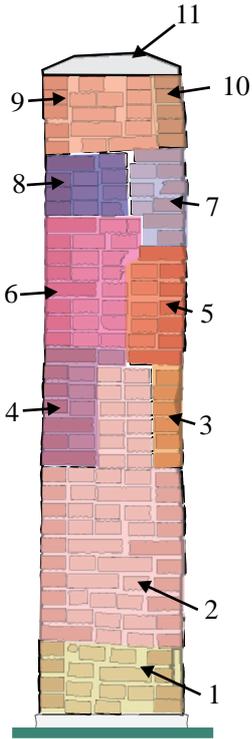
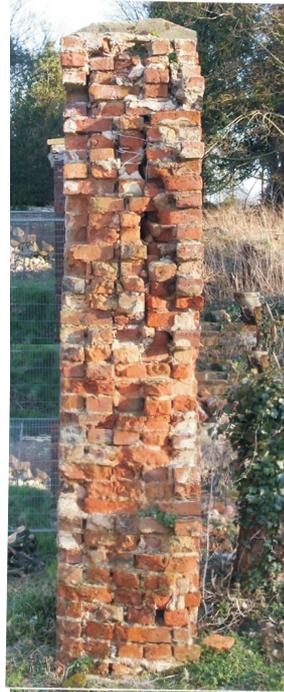
The brick style used is English Garden Wall bond, which is specific to strong walling techniques and would have been a commonly employed method in the 18th century, matching the date of the bricks. The bricks measure 235 mm x 64mm x 83mm (9 ¼ " x 2 ½ " x 3 ¼ ") and are hand-made, most probably locally. The thickness of the wall (640 mm or 2'1") allows space for the internal horizontal flues, four in total [003-6], a vertical flue [007] leading to a chimney hole in the stone wall cope [010], and a further flue [008] that exits from the north face of wall [001]. There is a flaw in this design however: the internal stretcher courses of bricks that create the horizontal divide between the flues are not tied into the southern skin wall of brick (see Fig. 7).

The western half of wall [001] is solid, while the rest contains the system of flues previously described. Figure 7 shows the phasing for construction of the wall.

phases of construction for building wall [001]

Figure 7: Cross section of Wall [001] showing flues and possible phased construction of wall.
