The Templar Lodge Hotel,
Gullane,
East Lothian.

The Templar Lodge Hotel, Gullane

April-May 2011

Carried out on behalf of Lorn MacNeal Architects

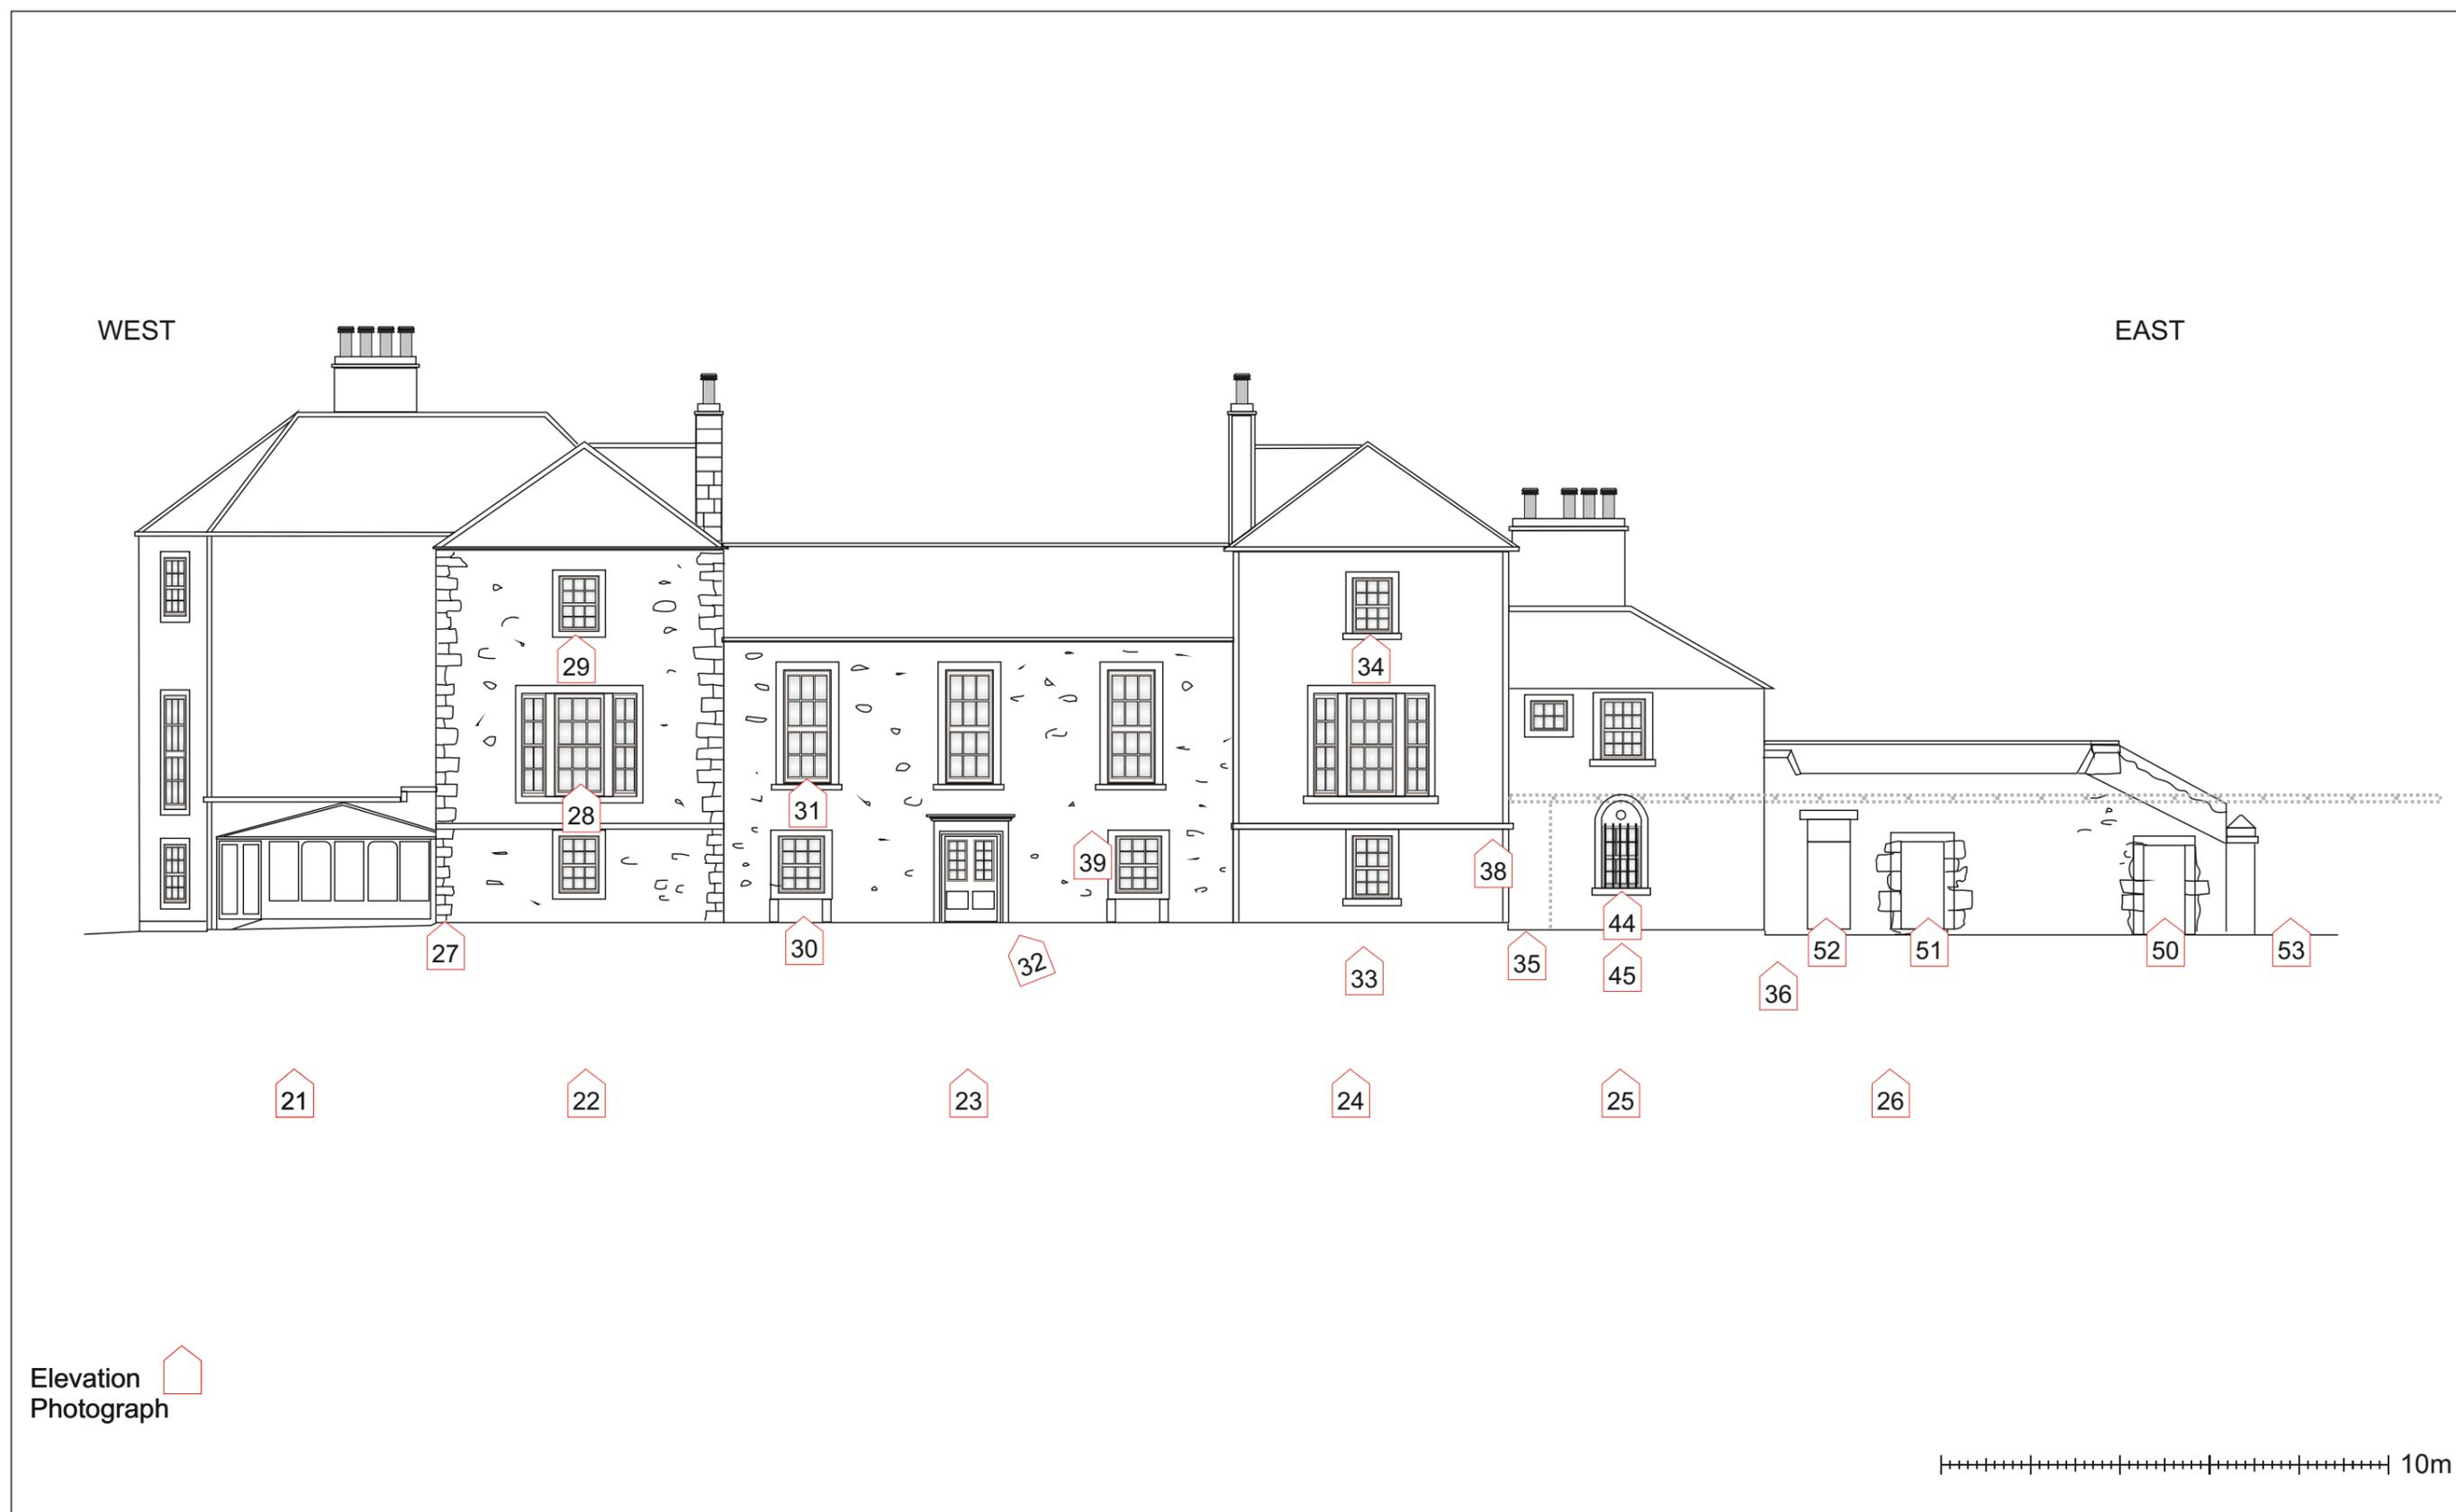
Figure 3: South facing elevation

5.2.1 The exterior does not provide much to explain the complex evolution of the structure, the whitewash and harl obscuring most constructional details. It is clear however, that the left pavilion with it's in-out quoins is the original structure built on the site in the mid 18th century. The rear and right pavilion follow and it is then that refenestration is conducted across the building.

5.2.2 The right pavilion has a simple raised margin however it has continued with a first floor string course that is also present on the earlier structure. Remaining windows do point to the original structure having a series of 2 bays on the west elevation and the door being in the east elevation with the doorway now incorporated in the centre of the principal elevation.

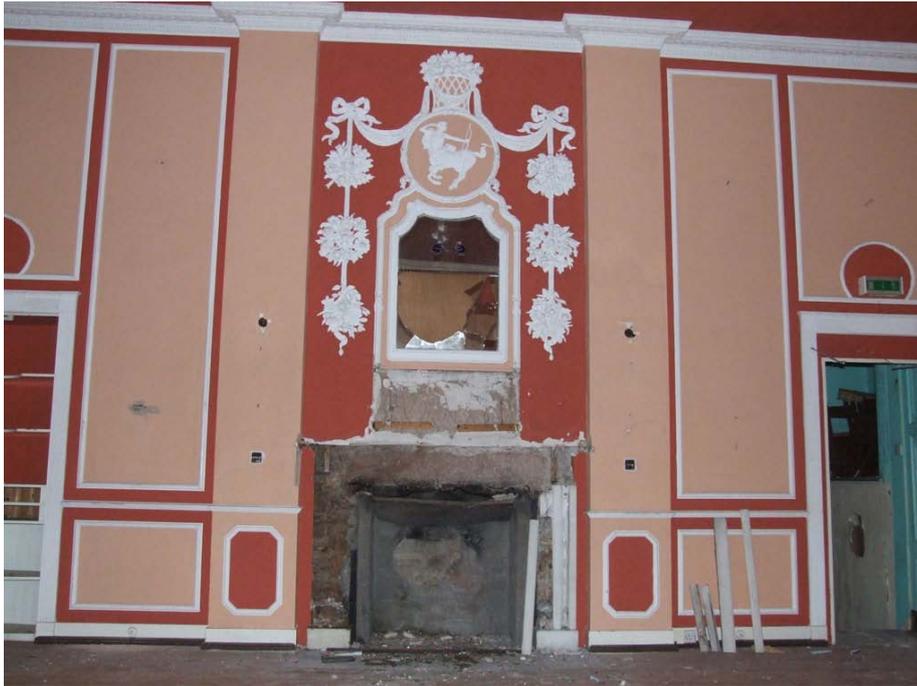
5.2.21 Structure 5 Room 13 / West Hall (see image below)

Elegantly proportioned Georgian extension with later plasterwork and white marble fireplace (removed). Canted bay to west with 3 x 6/6 sash and case windows to full height. Doorway to the north elevation leads downstairs into the later 60s extension. However, this was originally an alcove. Entrance was by a single doorway in the southeast corner. Entrance by a single doorway in the southeast corner.

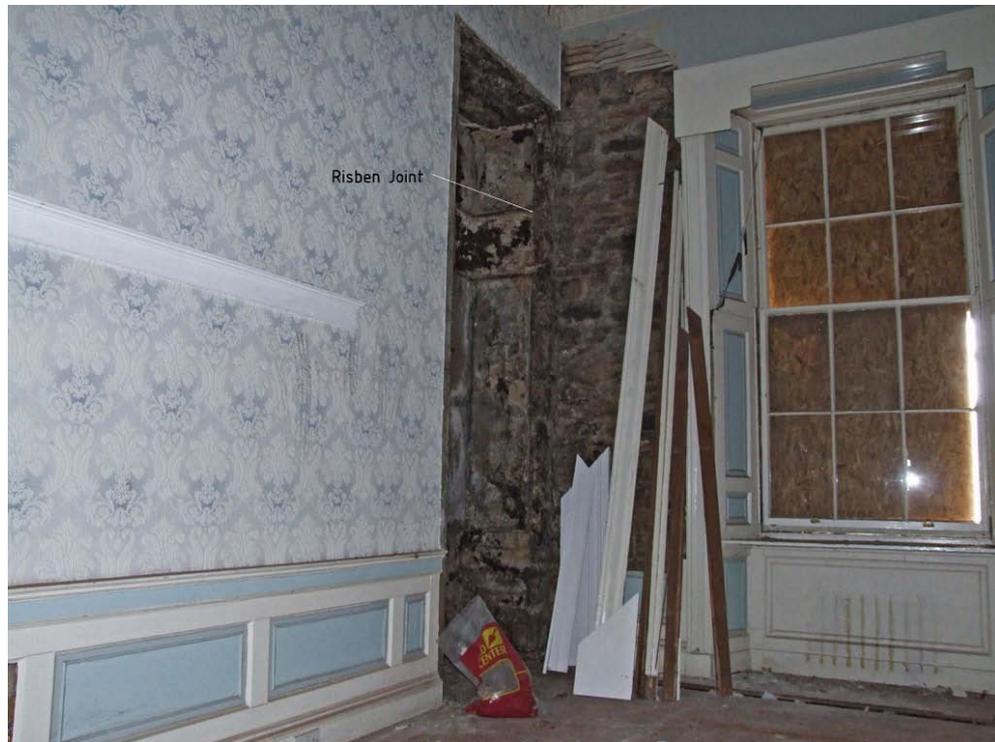
5.2.25 Structure 7 / Room 16 / Mid Hall (see image below)

60mm floorboards. Fireplace in west elevation and blocked fireplace in east elevation. Tall cupboards and press in the southeast corner. Shows risben joint between north south wall and east west façade. (See photo 99). Two doors in north elevation with large Georgian surrounds. South elevation contains three window bays with large 6/6 sash and case. Acanthus leaf cornice.
