1-4 Pitcox Farm Cottages, Pitcox, East Lothian

Data Structure Report

January 2017

On Behalf of:	S Findlay Pitcox Farm Dunbar East Lothian EH42 1RQ
National Grid Reference:	NT 64308 75231
Planning Reference:	16/00439/P
OASiS ID:	connolly1-273788
Prepared by:	Connolly & Kdolska
Date:	26 th January 2017

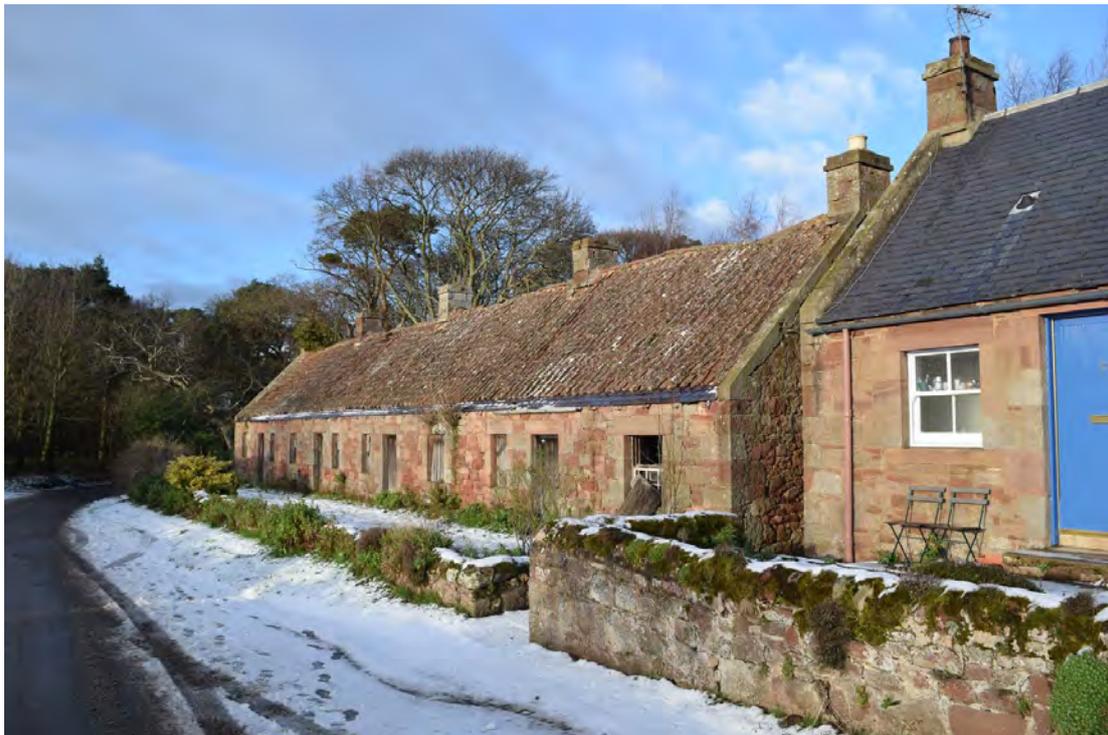
Plate 12: View of 1-4 Pitcox Farm cottages to the northwest, with one of the later cottages to right

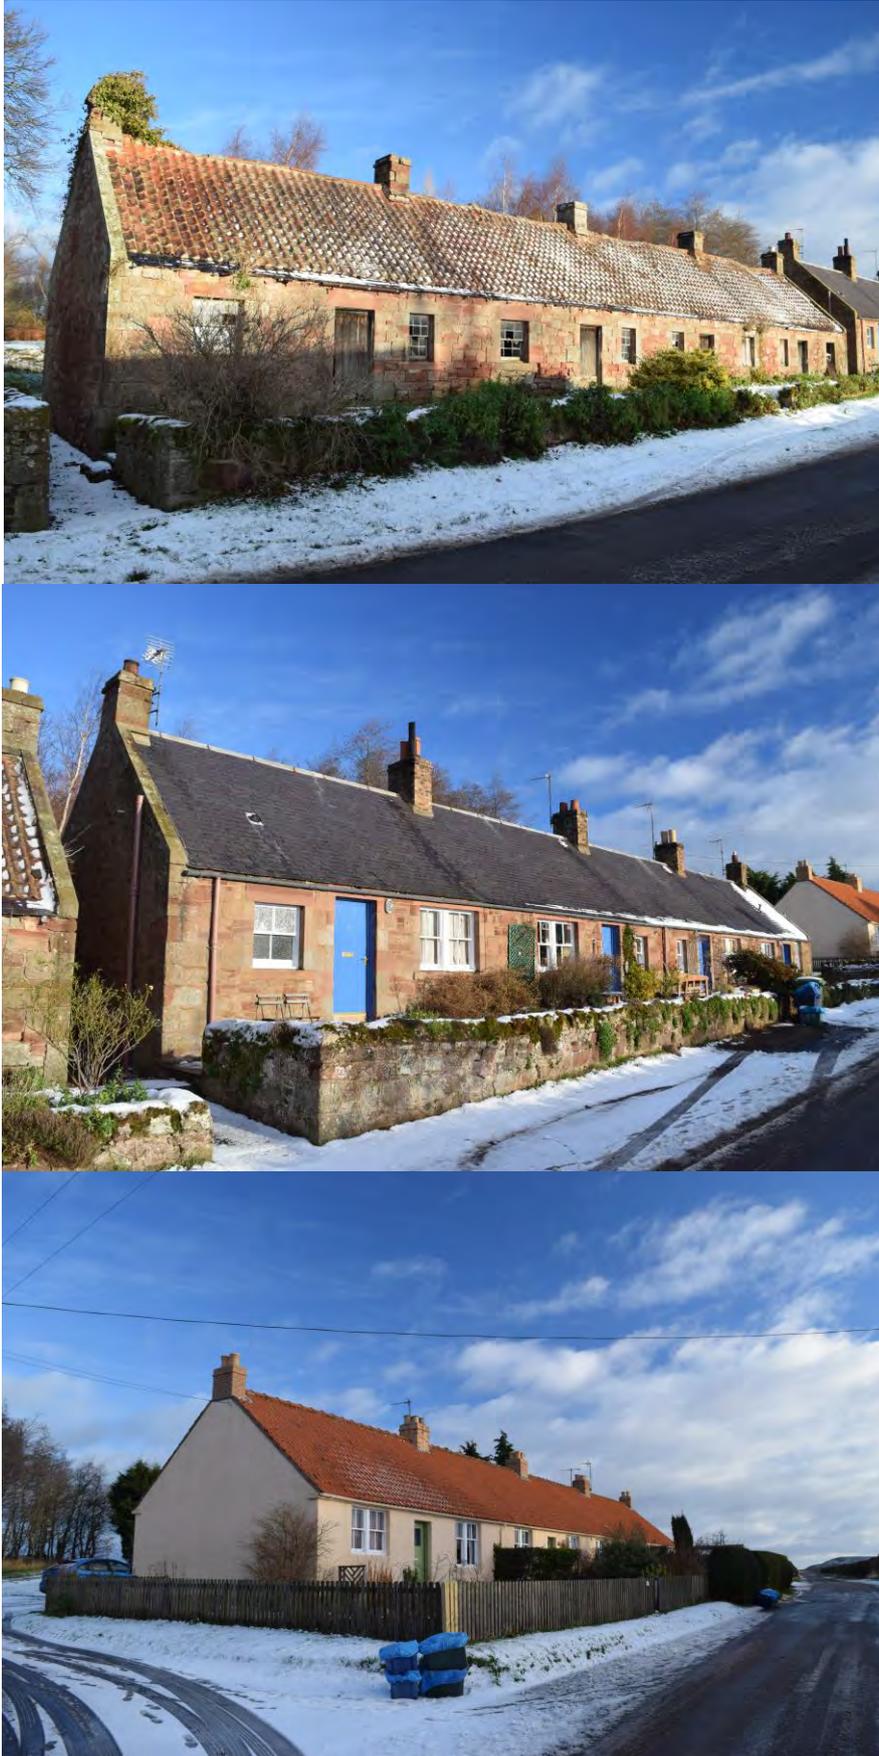
Plate 2: The three-phase development of the Pitcox cottage rows, 1836 (top), 1840s and 1950s

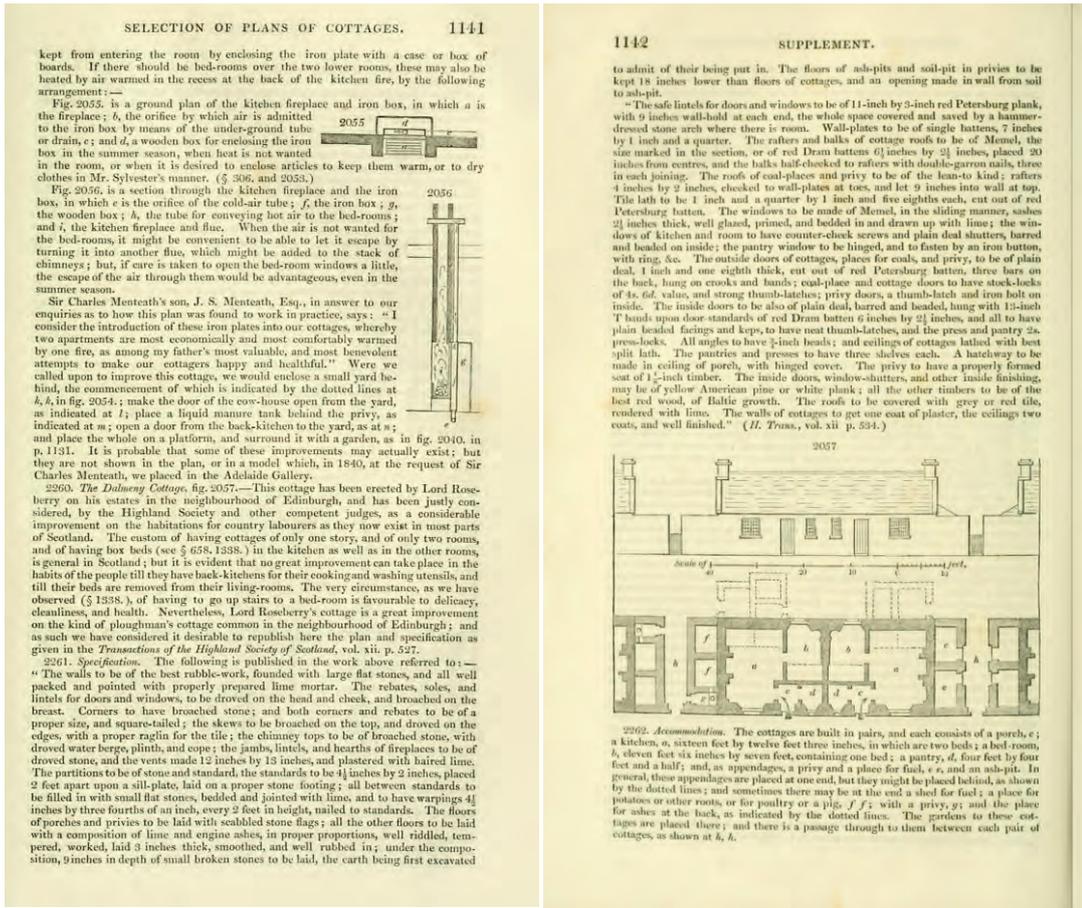
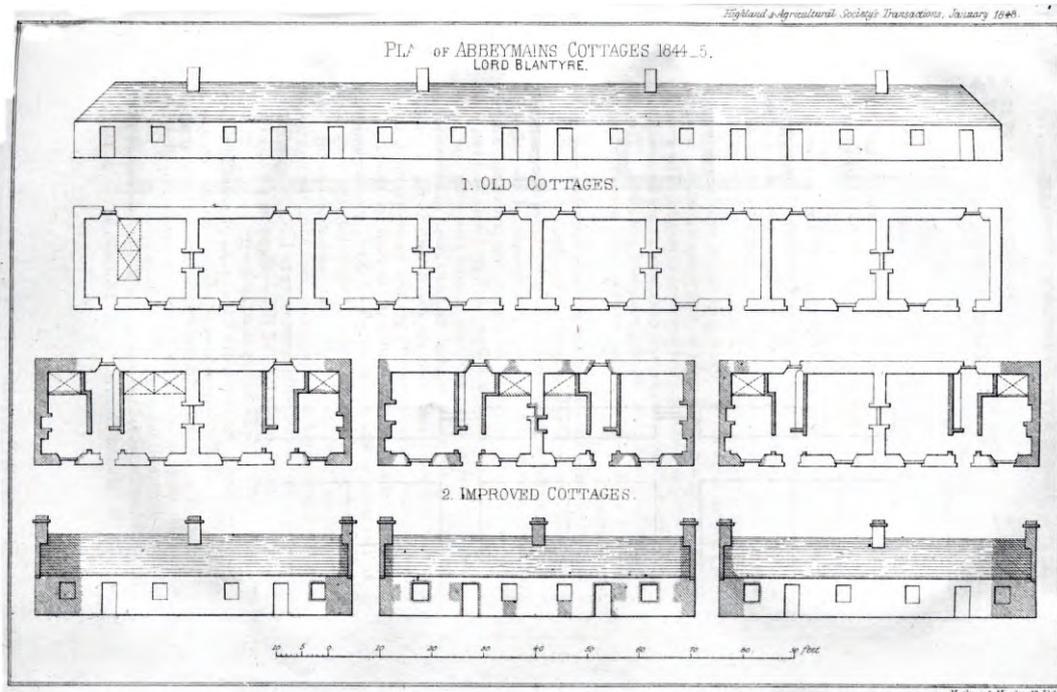
Figure 4: Plans and accounts of model 'improvement cottages' from 1833 and 1844

John Claudius Loudon. 1833. An encyclopædia of cottage, farm, and villa architecture and furniture Longman, Brown, Green and Longmans, London 1141-2.

Plan and elevations (Transactions of the Highland and Agricultural Society of Scotland 1848) Report on Lord Blantyre's Improvements on the Cottages at Abbeymains, Lennoxlove Estate, 1844

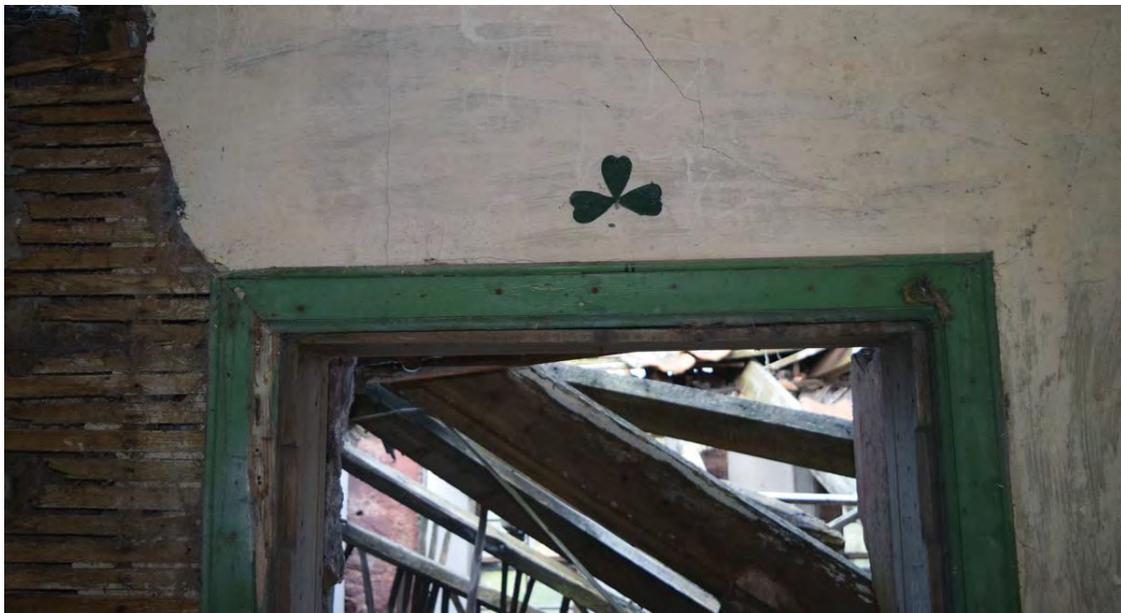
Finally, the last known/recorded resident of the cottages was a person known locally as 'Eddie the Irishmen', who stayed in Cottage 1 in 1960s, performing tasks of agricultural labourer (S. Findlay pers comm). He left his own distinctive mark in the form of a shamrock above the door into the rear extension (Plate 6).

Plate 13: Cottage 1: Shamrock placed above doorway into Room 5 from Room 2, presumably by 'Eddie the Irishman'.

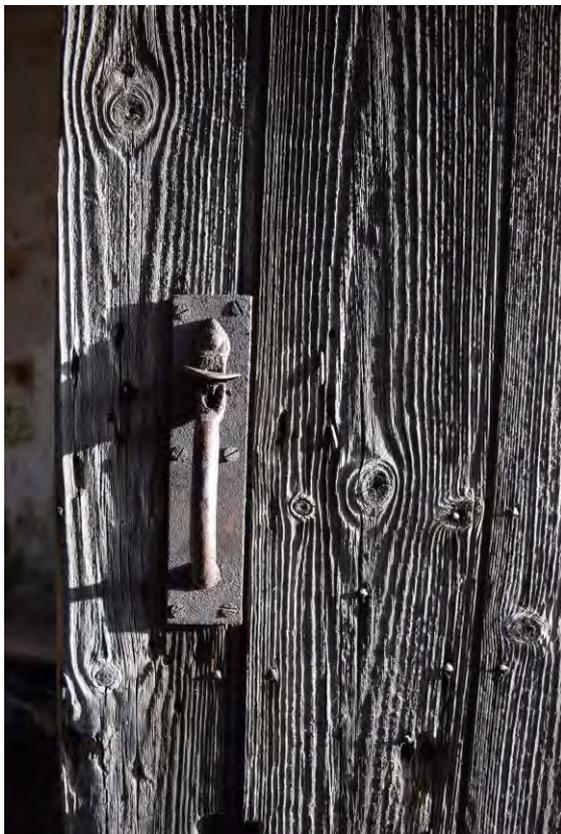
Plate 14: Cottage 2–Exterior door latch

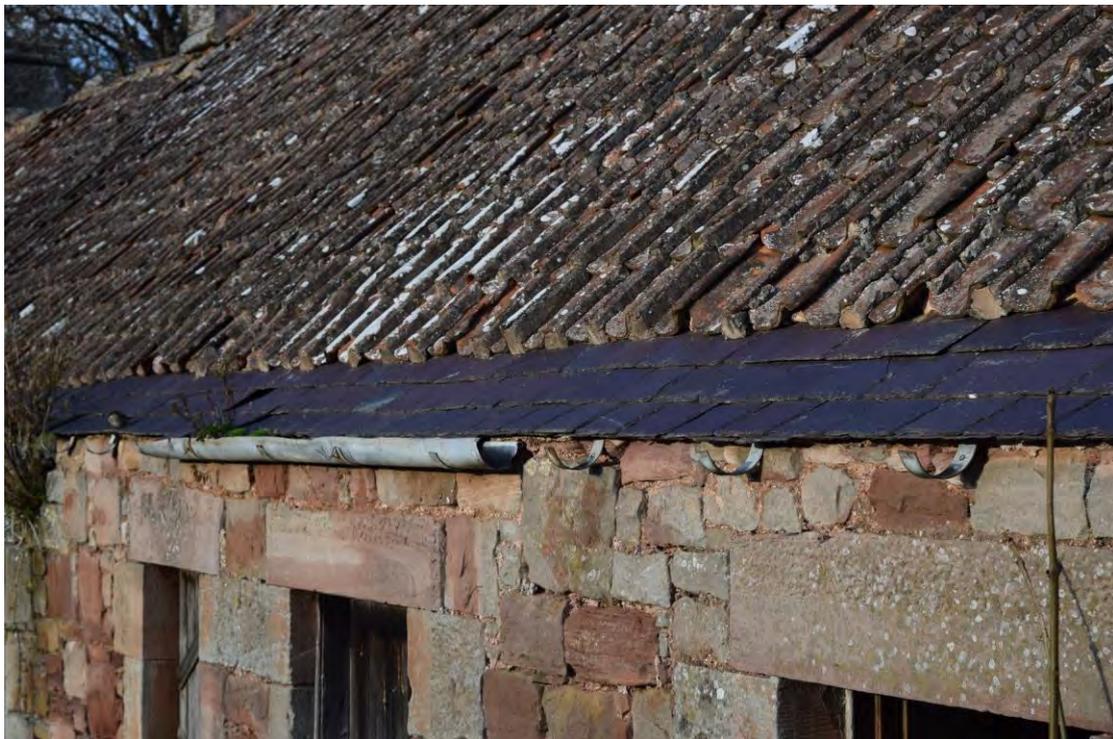
The pitched roof of the original structures is of pantile, with easing courses of slate (three courses) at the roof base (Plate 8). The slate is of purple blue, suggesting it may have been imported, rather than being of more typical dark blue/grey to black Scottish variety (HS 2000: 78) and most likely represents an (undated) episode of partial re-roofing or repair. This interpretation is also based on the assumption that the local tradition would have used pantile to the eaves. The state of the roof– i.e. the haphazard arrangement of pantiles in places and their binding with cement– also hints at an episode (or several episodes) of roof repair, not undertaken by skilled roofer. The guttering is supported on zinc supports placed directly on the wall head, with small fragment of zinc guttering surviving to the E and a small portion of cast iron guttering retained to the W.

Plate 15: – Roofing on cottages (south elevation), with slate easing courses

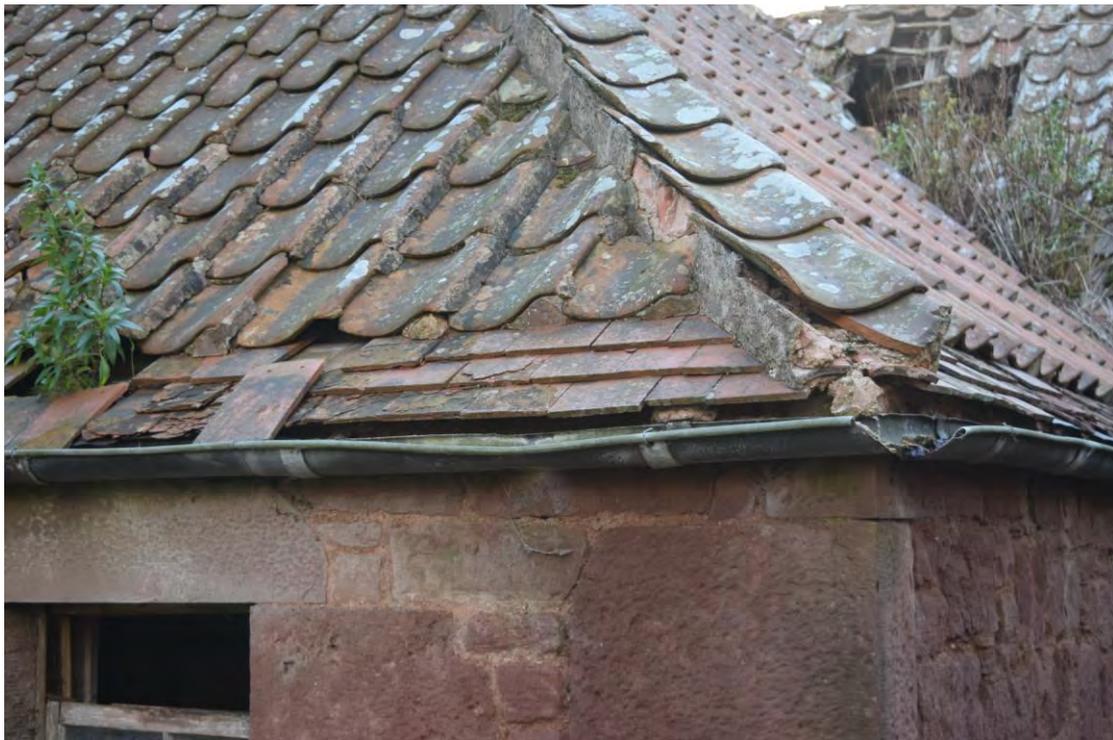
Each of the two extension blocks (Rooms 5-7) is crowned with two piended roofs. Each roof is pantiled with clay tile easing course at the base, consisting of three courses of red clay tile overlying grey slate (Plate 9). The ridge of the piended roof is unusually formed of pantiles, as opposed to the semi-circular clay barrel ridge tiles. The guttering is of zinc with surviving portions of zinc down pipes. Between the two piended roofs are two further ashlar chimneystacks, each serving two flues for the two fireplaces within each of the extension blocks (Room 6).

Plate 16: Roofing on cottages (north elevation), with clay tile easing courses and pantile ridge.

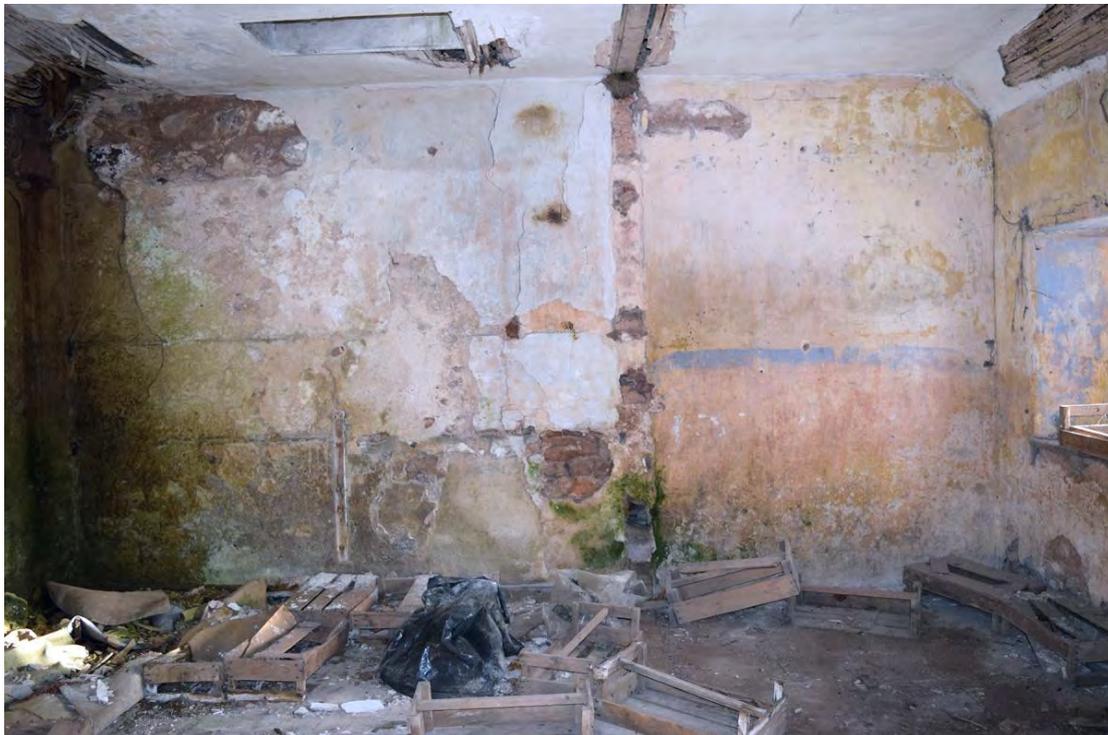
The original cottages consisted of four rooms in total, each room separated by plastered brick partition walls (Plate 10). The original partition walls are only surviving upstanding in Cottages 3 and 4; in Cottages 1 and 2 their former presence is indicated by scarring on the walls and remains of brick arrangements on the floor. The interior division consisted of a small porch (Room 1); a main room with multiple purpose use, as living space, kitchen and bedroom (Room 2); a storage room/pantry (Room 3) and a small bedroom (Room 4), later turned into a storeroom, as suggested from remnants of shelving units. The porch (Room 1) is accessed directly through the centrally located entrance and forms a small approximately square southern chamber in each cottage. In Cottage 1 and 2 the main room (Room 2) forms a large spacious chamber to the E; the pantry/storage (Room 3) forming the SW chamber and the bedroom/storeroom (Room 4) the NW chamber. This arrangement is mirrored in Cottage 3 and 4.

Plate 17: Walls plastered on the hard and showing scars of brick partition walls (Cottage 1)

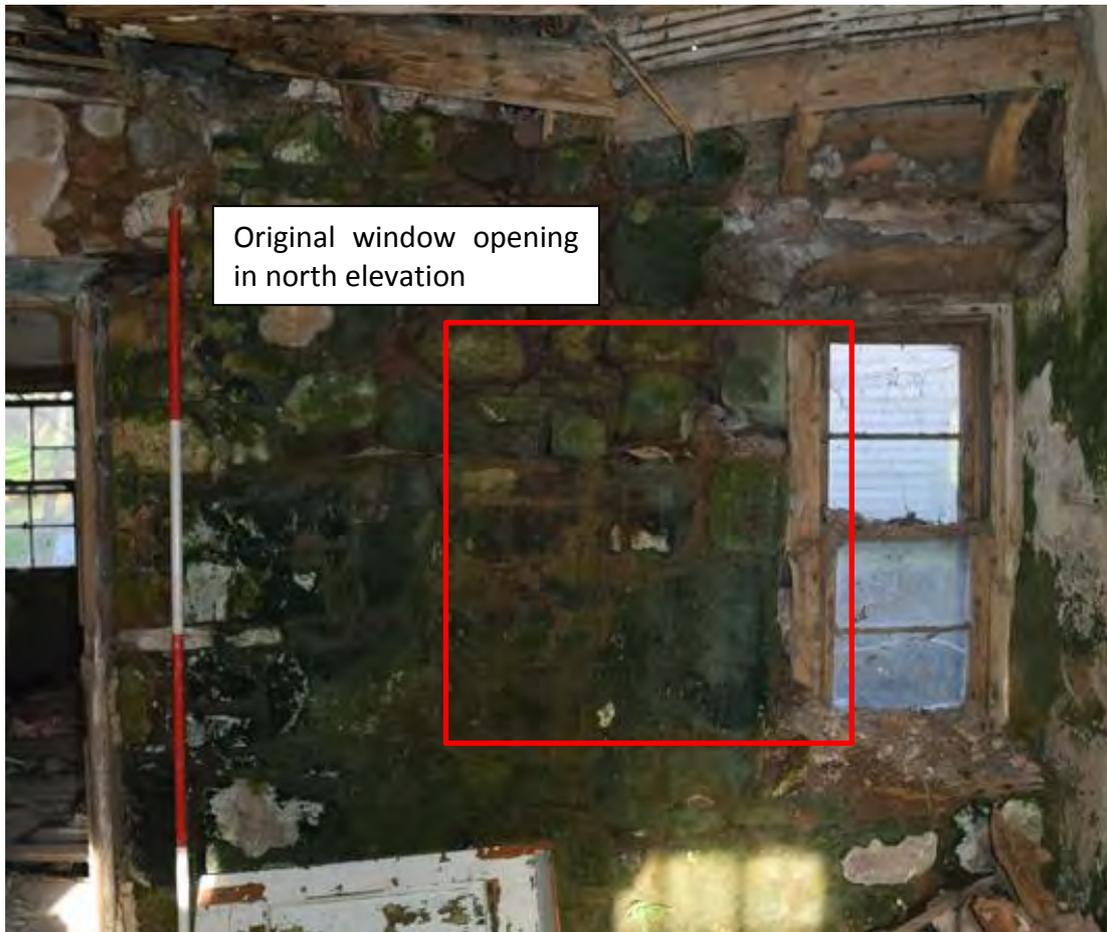
The blocked window in Room 4 was in Cottages 2 and 3 reconfigured/ replaced by new windows, placed adjacent to the original blocked openings (Plate 11) as part of the extension phase– the two new windows fitting in the space between the two extension blocks (see also above). A later sky-light window has been inserted into the ceiling of Room 4 as part of the extension works. All window openings were splayed with simple wooden shutters and beaded surrounds.

Plate 18: Blocked and inserted window in north wall of the original structure (Cottage 1, Room 4).

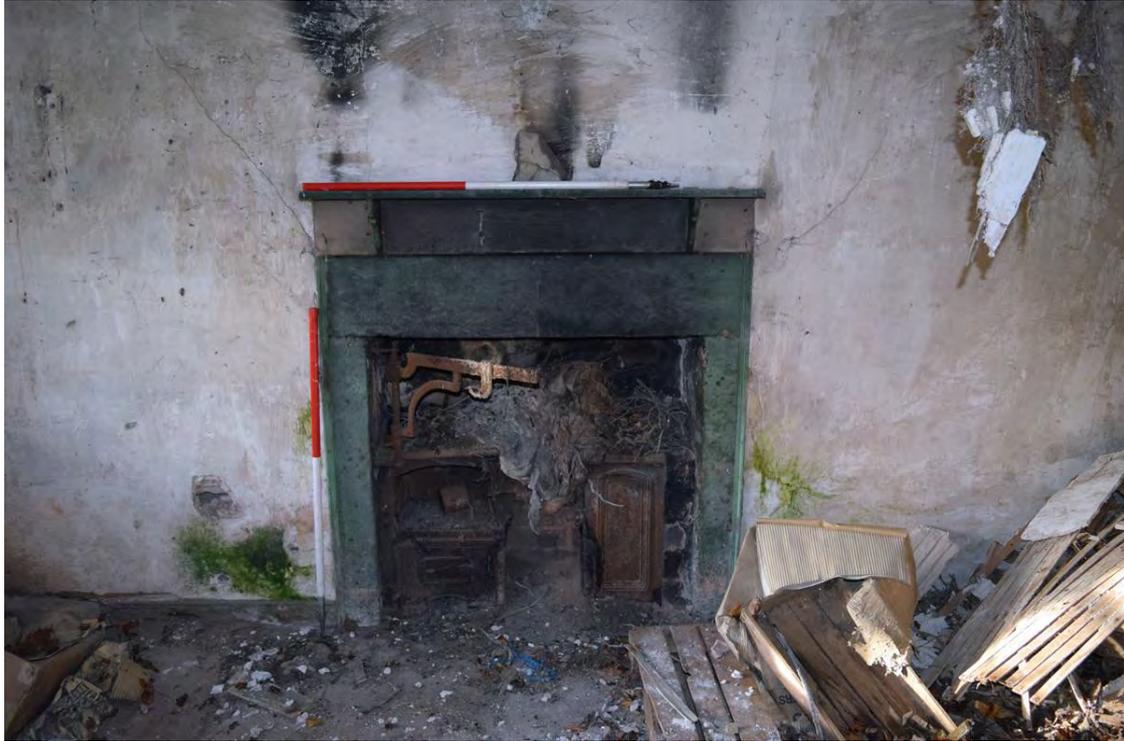
The main chamber (Room 2) in all four original cottages would have been heated by a single cast iron range, also providing a cooking facilities and located centrally on the W elevations (Cottages 1&2)/ E elevation (Cottages 3&4). The range has stone surround and wooden mantelpiece (Plate 12). Room 4 would have originally included a small fireplace blocked during extension works, when the room ceased to function as a bedroom and became a storage room. Although no evidence of the fireplace was found within the chamber (Room 4), the central chimneystack (serving Cottages 2 &3) testifies to their former presence, now disguised beneath wall plaster.

Plate 19: Cottage 3–Fireplace range in main Room 2

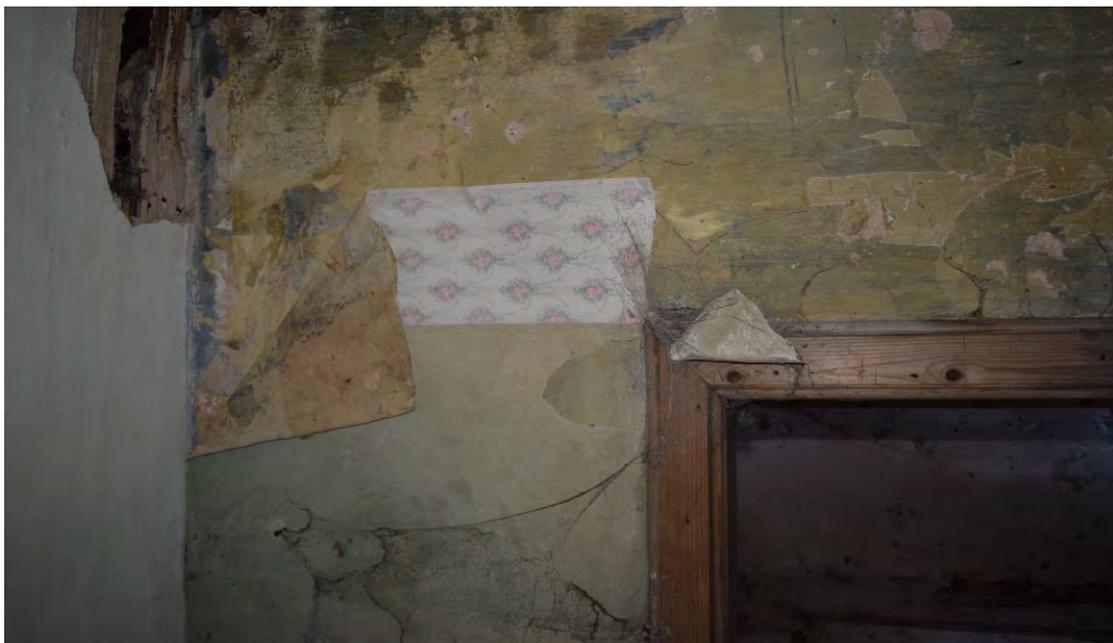
The flooring of the original cottages was composed of stone flags, surviving in all four cottages. The masonry walls were plastered on the hard and in places retain remnants of wallpaper (e.g. Cottages 3 & 4, Plate 13). The walls were capped with coved lath and plaster ceiling. The exception is Cottage 1, which was at some point refurbished, and which has with the walls and the ceiling retaining lath and plaster and the walls provided with lath and plaster overlapping the original ceiling (Plate 14).

Plate 20: Wallpaper traces on the wall in Cottage 3.

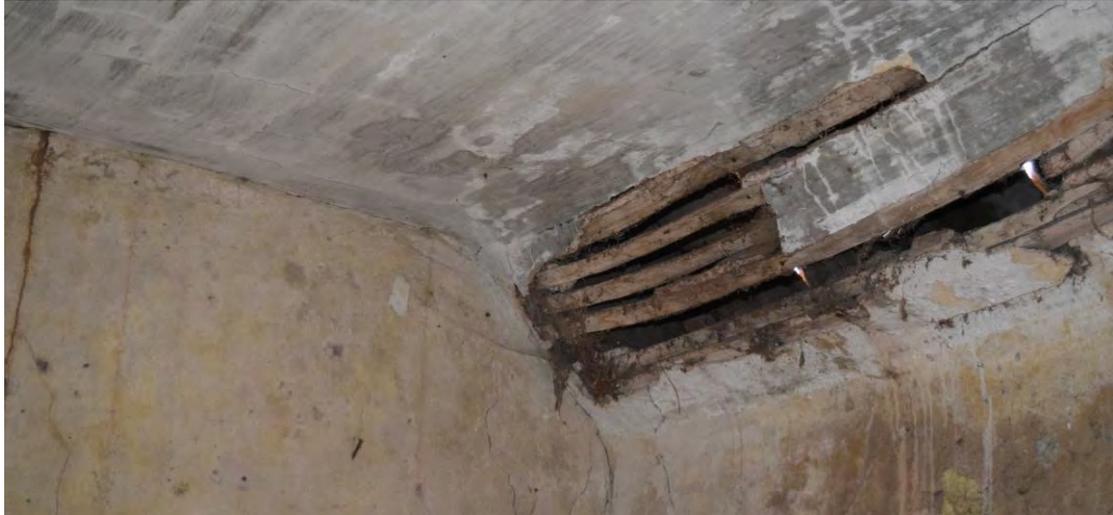
Plate 21: Lath and plaster covered ceiling.

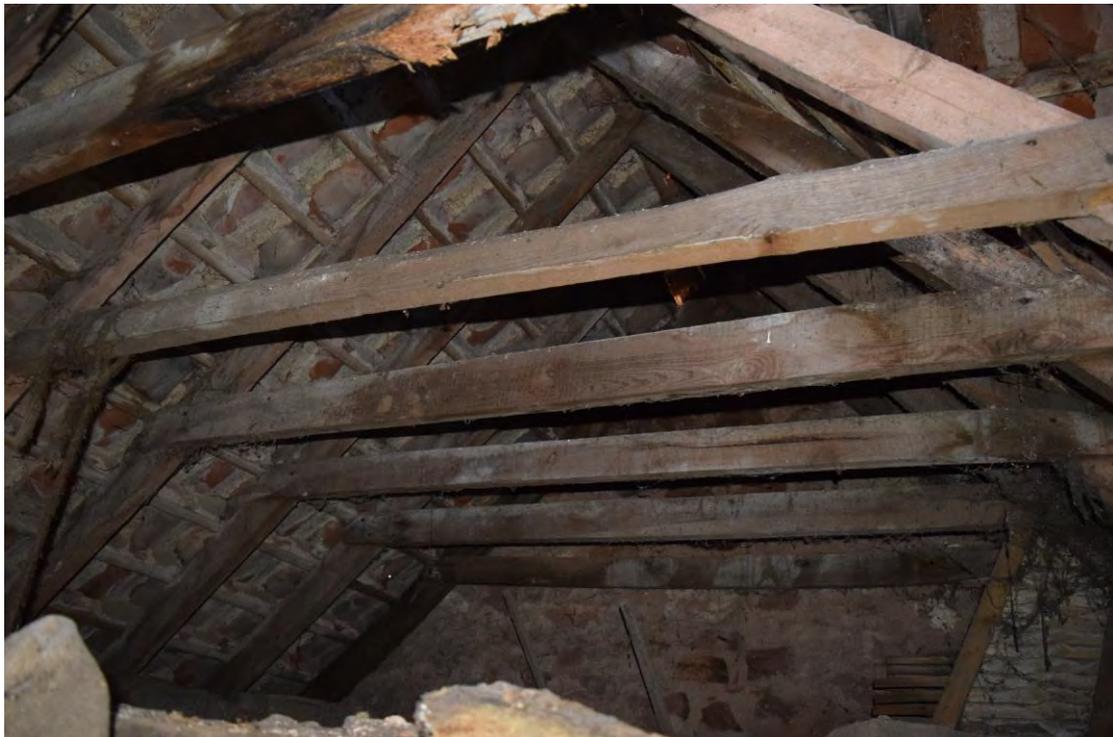
The interior upper structure of the roof in all four original cottages was visually inspected from the ground level, due to its hazardous conditions. The roof is of sawn timber with no sarking. The A-frame rafters retain carpenters marks (i.e. XII and VII) for easy assembly on site (Plate 15). Each roof also includes purlins and battens for hanging pantiles.

Plate 22: Main A-frame roof timbers with carpenters marks in the original cottage.

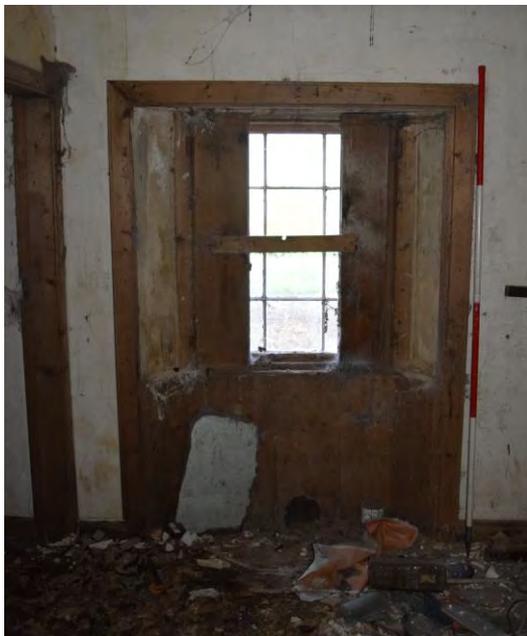
Plate 23: Cottage 3, Room 6–Window opening showing panelling, architrave & shutters

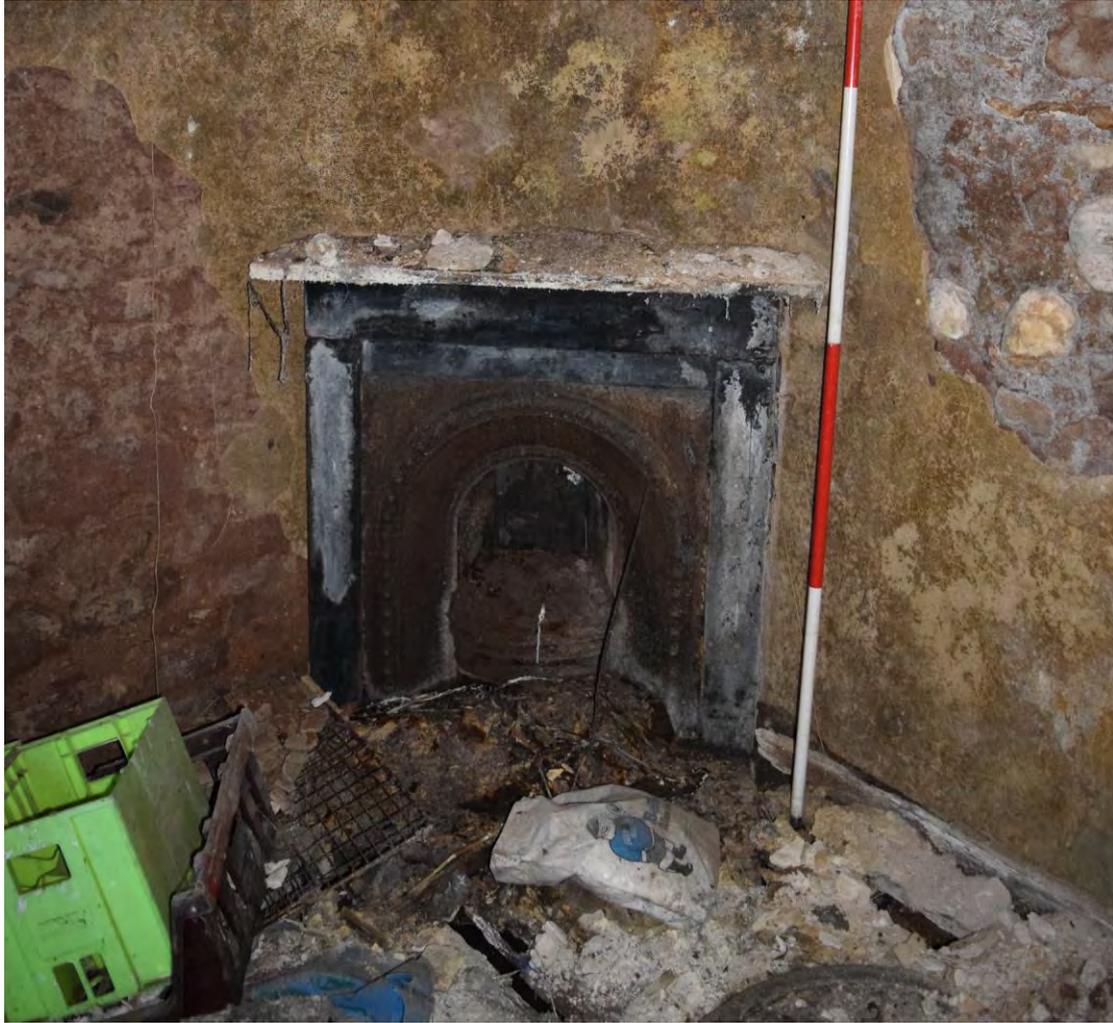
The interior upper structure of the roof in the extensions (block 1 and 2) was visually inspected from the ground level, due to its hazardous conditions. The roof is of sawn timber forming A frames and, as with the original cottages, contained partial sarking boards on the lower courses to accept clay tiles or slates on the lower three easing courses of the roof.

Plate 24: Cottage 3–Corner fireplace in room 6 (bedroom)

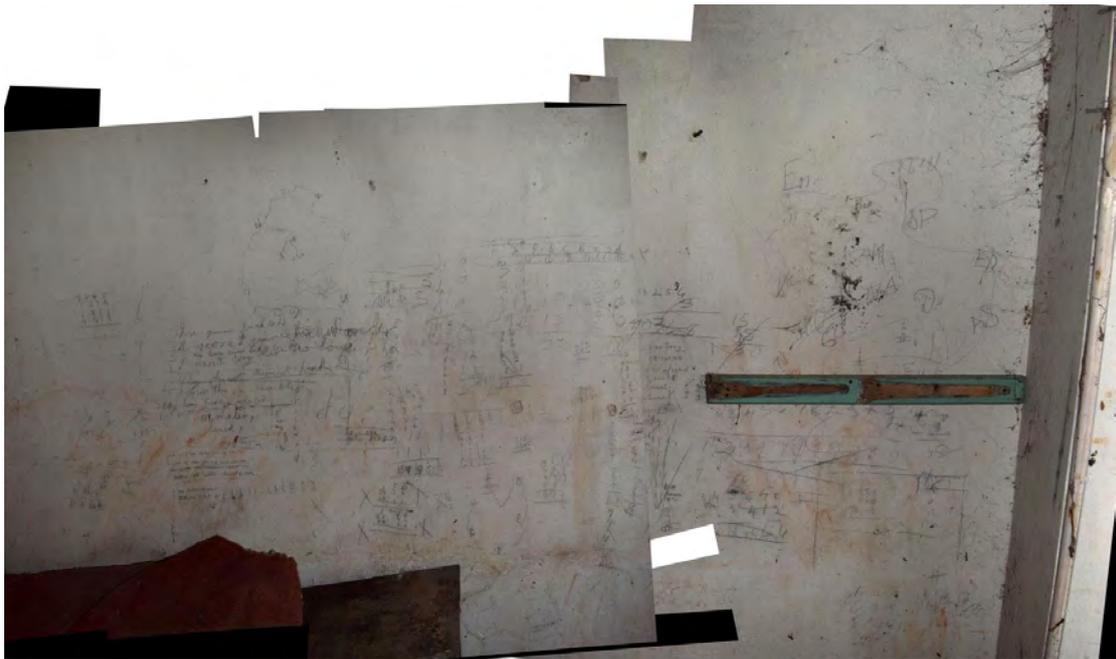
Plate 25: Cottage 3, Room 7—Graffiti [Gr7] covering most of the west wall.

Others were probably made by some of the many itinerant agricultural labourers frequenting these cottages until mid 1940s (Figure 6; Appendix 2). In Cottage 3 (Room 7; [Gr7]) the W wall probably served as an impromptu school blackboard (complete with pencil lines emulating lined paper in an exercise book), as it is covered in what can only be describes as attempts at writing and basic arithmetic amongst other things (Plate 18).

Many of the Rooms within the cottages (both the originals and extensions) include a wide range of mostly pencil graffiti on the walls and window shutters or surrounds (Plate 18), which provide insights into the later occupation of the cottages—from late 1930s to c 1960s. Other graffiti can be seen on the door and window surrounds carved into the sandstone, and consists of initials and dates and childish drawings. All have been digitally photographed to record this ‘fleeting glimpse’ of the past for posterity and examples are presented in Appendix 2.
