Newhailes House Estate, Flower Garden Wall recording.

March 2007

Carried out on behalf of the National Trust for Scotland

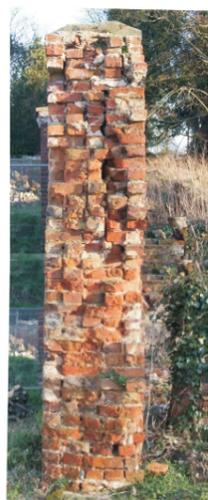
Figure 3: Top: Wall showing area to be repaired and position of bricks
 Middle: Wall recorded as seen
 Bottom: Photomontage of wall.

This programme of works has recorded the walls as specified. An elevation of repair has been produced (Fig. 5) and the construction and operation of the flue has been interpreted (Fig. 6).

Further remedial work will be required on the east wall, to both repair the collapses and also to ensure that the flue and heating system is repaired fully, as the entire system must be rebuilt and cleaned before any of it will function. A glasshouse could be reconstructed on the foundations present, in which case further recording work would be required on the remainder of the wall, and plans made of the foundations. Research on similar structures would be useful.
