The Templar Lodge Hotel,
Gullane,
East Lothian.

The Templar Lodge Hotel, Gullane

April-May 2011

Carried out on behalf of Lorn MacNeal Architects

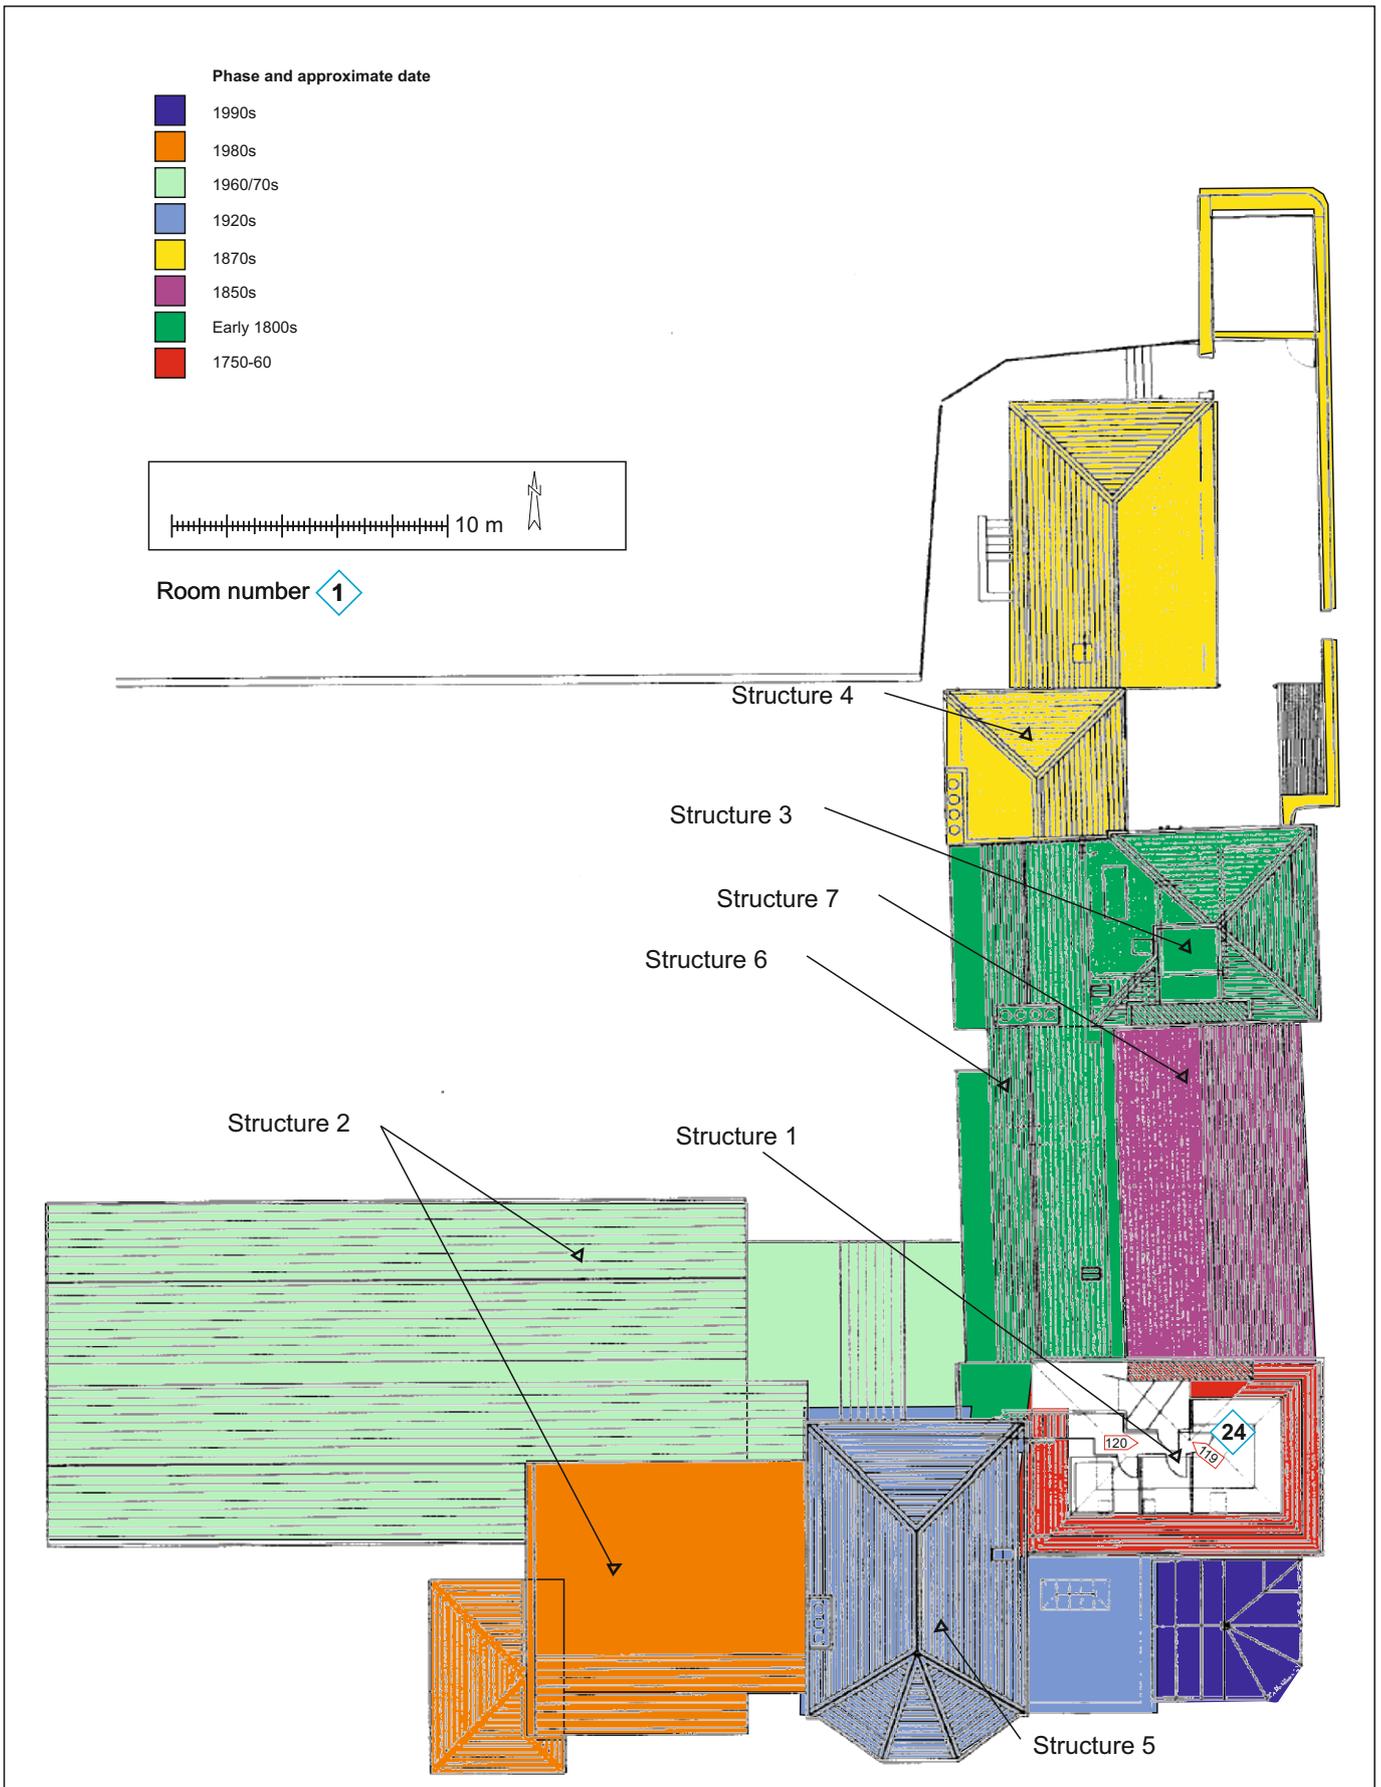
Figure 10: Third Floor plan

- 5.2.34 The general appearance of the structure is one of constant alteration and refurbishment, over what could be suggested is a relatively short space of time. However, the essential character of the building remains the same, a house that transforms into an elegant pavilioned mansion and then on towards an early 20th century hotel and later expansion to accommodate more guests in rather less elegant conditions towards the rear.
- 5.2.35 During the buildings appraisal and assessment it has been possible to re-evaluate and alter the previous building history and phasing, the results given in the conclusions and discussions below.
